TECHNICAL MEMORANDUM 98/202 January 1998

DEFECT CONDEMNATION FOR SUBMARINE PRESSURE HULL WELDS

Defence Research Establishment Atlantic

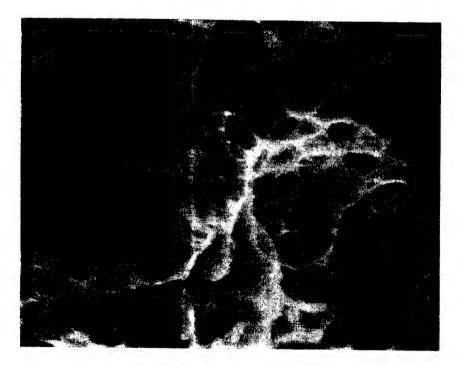
The mechanism of flaw propagation was identified as ductile as observed and by microvoids under the SEM.

Figure 6.2.2: SEM fractograph of typical explosively torn area displaying propagation by microvoids.
